Maintenance of Hydrofoil Systems

Konstantin I. Matveev

Abstract

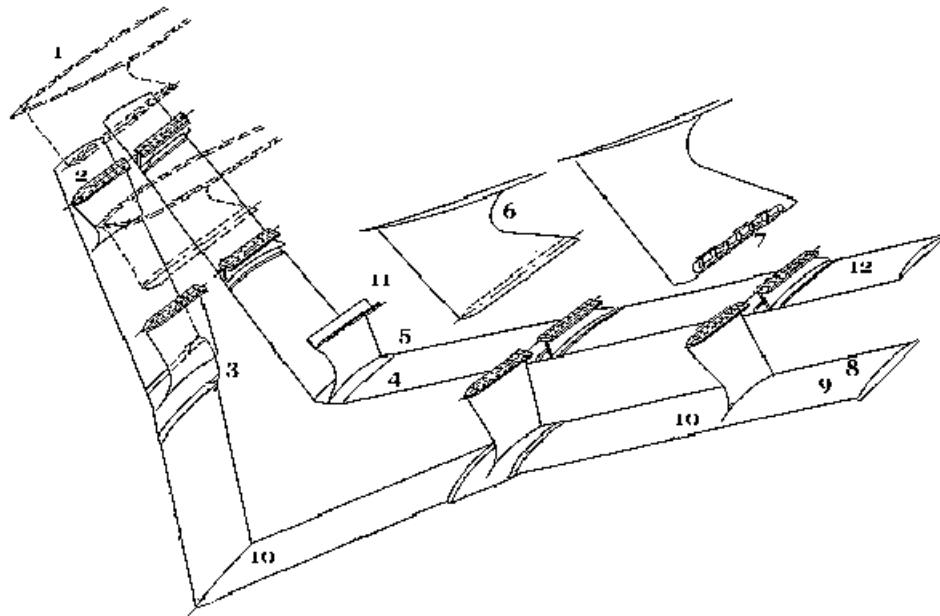
Main defects of the forward surface-piercing foil devices appearing in use of the Kometa 342MC type ships are shown in Fig. 1. The main foil and brackets are made from steel 12X18H10T; the stabilizer is made from aluminum alloy AMg-61. Crack formation on the deeply submerged foils are also reported to appear on American (Olling et al., 1981) and Canadian (Eames, 1983) developments. Elimination of cracks is carried out by welding with preliminary surface preparation. In the case of crack appearance on the strut and foil spans, additional lists are installed.

Fig. 1: Scheme of typical defects on the fore foil system on Kometa 342MC: (1) breach in isolation between foil system and hull; (2) weakening of bolt connections between strut and bracket; (3) cracks along the trailing knives near the struts; (4) cracks on both sides of the stabilizer near welds; (5) cracks on upper side of stabilizer between struts; (6) cracks along welds on the aft sides of brackets; (7) cracks along welds on the lateral side of brackets; (8) swelling on both sides of consoles; (9) cracks on the upper sides of consoles; (10) single cracks on both sides of foils along welds of the trailing knives, and bending of foil surface; (11) cracks along welds near hull-strut connections; (12) corrosion of the stabilizer surface

Hydrofoil singing has very negative effects: first, the noise level is unacceptable for passenger transportation; second, vibration of the foil structure participating in singing effect leads to fatigue of the system and crack formation in the regions of aft knives on foils and struts (Fig. 1). Elimination of hydrofoil singing on foil devices made from stainless steel was usually achieved by cutting the trailing edge, so that natural frequency of the system was increased and vortex shedding frequency was decreased. However, this approach is unacceptable for foils made from titanium alloy; the necessary length to be cut is so large that it would lead to the degradation of the hydrodynamic properties. A new method (Matveev, I.I. et al., 1997) was proposed: the trailing edge is lifted by a certain value by special profiling, and the curvature of the surface on the lower side of modified part is selected to be smaller than the one on the upper side. This procedure allowed elimination of the tonal sound without degrading the lift-drag ratio of the vessel. Nowadays that method is successfully applied on other hydrofoils.

Bending and swelling of the foil surface are removed by thermoplastic and mechanical methods. The first procedure is applied at small deformations (5 mm per 1 m) by heating and cooling the distorted foil surface. Heating is carried out in spot manner when metal thickness is less than 4 mm; otherwise - in strip way. The mechanical method is applied for bigger distortions and accomplished by hammer or special

devices. Significantly damaged surfaces are substituted by whole lists or sections. In repair process stress concentrations in various connections should be smoothed out. Welds are located in areas with low tension, their number is minimal; and distances between them should not be too small.

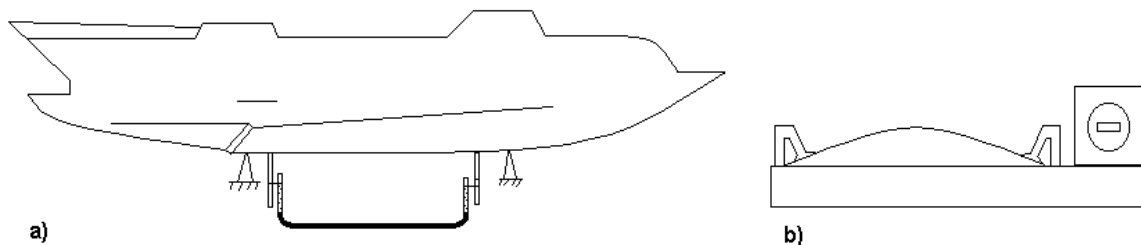
Fig. 2: Measurement of installed attack angle: a) determination of hull inclination by a hose level; b) finding the installed angle of the foil plane by a quadrant

Measurement procedures check the installed incidence angles, the geometry of profiles and positioning of the foil system with respect to the hull. This inspection is carried out upon worsening of ship performance due to damage of the foil systems (collisions with floating objects and sea's beds); before operational season; and after repair of foil devices. Checking of foil profiles is carried out by templates or rulers; installed incidence angles – with the help of strings, optical quadrant, and a hose level (Fig. 2). Note that the angle of baseline inclination to the horizontal line should be also determined. Elimination of the error in installed incidence angles is accomplished by detachment of the foil system and installing the appropriate wedge gaskets in hull-bracket or strut-bracket bolt connections.

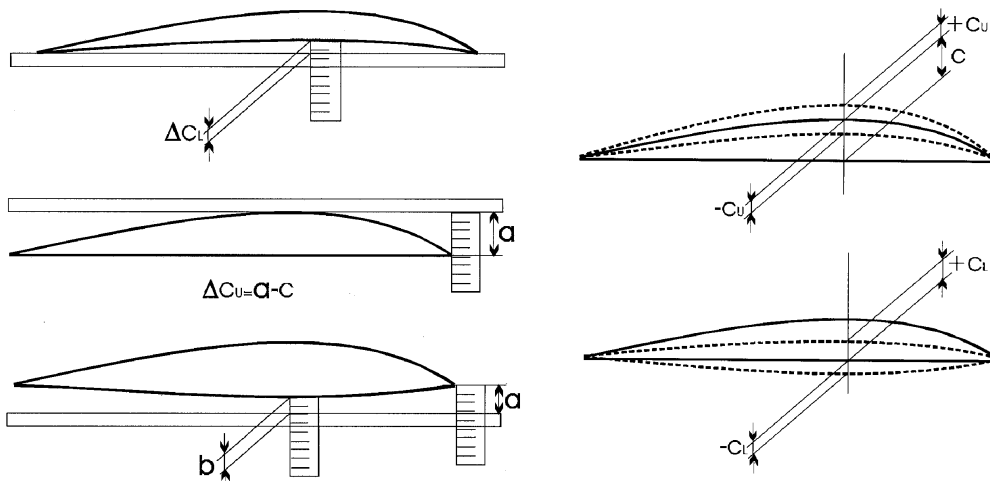
Fig. 4: Measurement technique

The increment of the angle of incidence is found by measurements as the difference between the actual and design values. We express the second term in (2) in terms of distortion of the profile. The characteristic deformations of the cross-sections, which cause the change of the mean line and profile thickness, are combinations of the distortions of the upper and lower surfaces of the profile (Fig. 4).

Method for finding deformations of a plate-convex profile is shown in Fig. 4. Such measurements are carried out at several stations to find the local deformations.

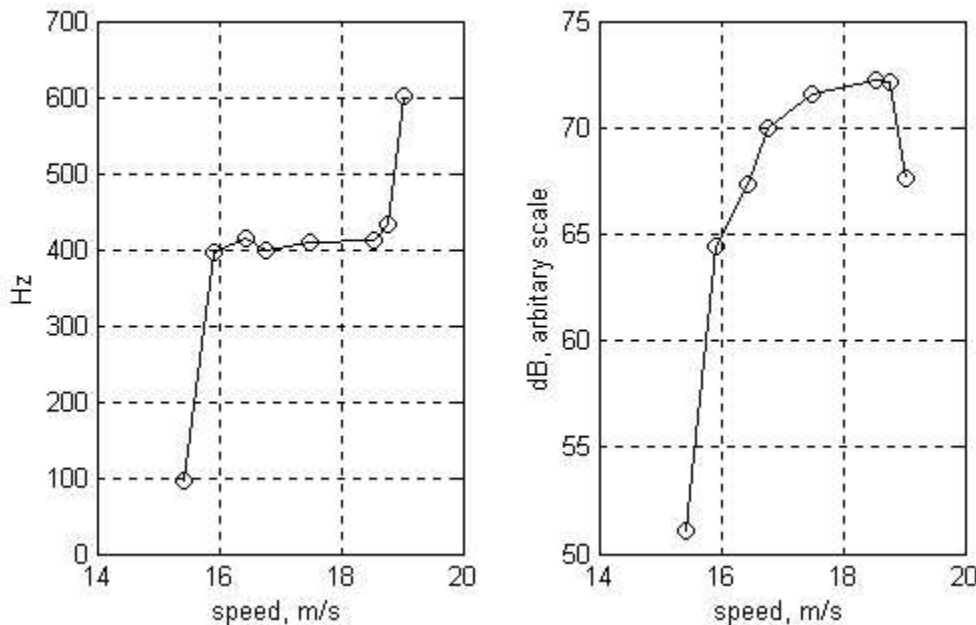
Experiments carried out in trials of the first Olympia type ship (Matveev, K.I. et al., 1997) demonstrated the validity of this model. Hydrofoil singing was recorded over the wide range of speed, and different harmonics were observed. In Fig. 9 the dependence of the dominant frequency and the intensity of the 400 Hz tone are given for the speed interval 15.5–19 m/sec. The locking region is clearly pronounced, and within it, sound power is high.

Fig. 9: a) Dominant frequency at speed range 15.5-19 m/s, b) intensity of 400 Hz tone versus speed
