Maintenance of Hydrofoil Systems

Konstantin I. Matveev

Abstract

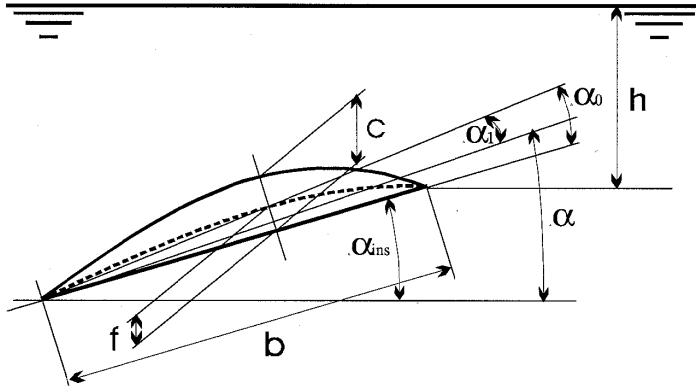
Fig. 3: General configuration

The foil profile characteristics, namely the curvature of the mean line and the profile thickness, determine the attack angle α_0 corresponding to zero lift and the correction to this angle α_1 due to the free water surface (Fig. 3). The approximate expression for the lift coefficient (Voitkunsky, 1985) is

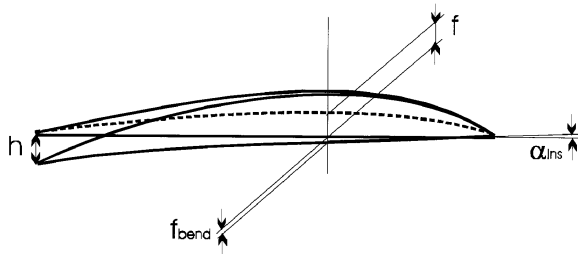
Fig. 5: Influence of bending on the attack angle

In order to keep the lift coefficient constant, the sum of the geometrical incidence angle and the angle of attack for zero lift must be zero. For the local character of the distribution of the deformations considered, it is inconvenient to compensate them by changing the installation of the foil system (or foil sections). In this case, it is effective to apply a correction to the deformed sections by bending the trailing edge (Fig. 5). For such corrections, not only the curvature of the mean profile line changes, but so also does the geometrical incidence angle. The values of $\Delta'\alpha_{ins}$ and $\Delta'\alpha_0$ obtained in this way have the same sign; that characteristic improves the effectiveness of the bending. Using dimensions considered above (angle in

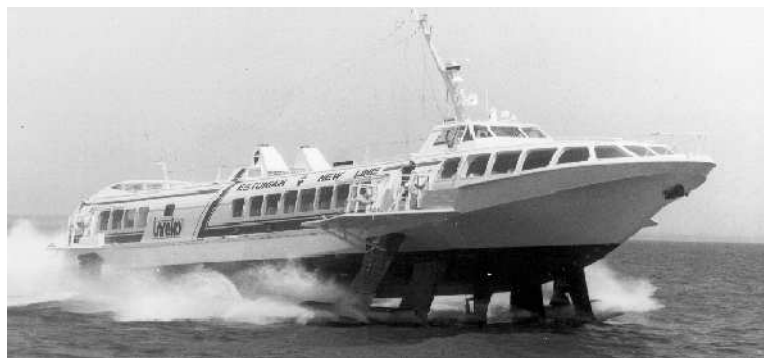
Fig. 7: Hydrofoil Olympia (chief designer – I.I. Matveev)

When a new hydrofoil ship is commissioned, so-called hydrofoil singing is sometimes observed. Hydrofoil singing is a tonal sound caused by interaction of the foil trailing edge with incoming flow. The intensity of the excited tone often exceeds the intensity of the noise from engine-propulsor and other systems. The problem of hydrofoil singing emerged on Russian-made river boats of types Raketa, Polesie and Dolphin with steel foil systems. But especially critically it was manifested on the sea-going Kometa and Olympia (Fig. 7), which has the bow foil system made from titan alloy.

Hydrofoil singing has very negative effects: first, the noise level is unacceptable for passenger transportation; second, vibration of the foil structure participating in singing effect leads to fatigue of the system and crack formation in the regions of aft knives on foils and struts (Fig. 1). Elimination of hydrofoil singing on foil devices made from stainless steel was usually achieved by cutting the trailing edge, so that natural frequency of the system was increased and vortex shedding frequency was decreased. However, this approach is unacceptable for foils made from titanium alloy; the necessary length to be cut is so large that it would lead to the degradation of the hydrodynamic properties. A new method (Matveev, I.I. et al., 1997) was proposed: the trailing edge is lifted by a certain value by special profiling, and the curvature of the surface on the lower side of modified part is selected to be smaller than the one on the upper side. This procedure allowed elimination of the tonal sound without degrading the lift-drag ratio of the vessel. Nowadays that method is successfully applied on other hydrofoils.
